COMPLIANCE EVALUATION INSPECTION REPORT

MAPCO Alaska Petroleum Inc.

Date inspected: May 27, 1994

ALASKA DEPARTMENT OF ENVIRONMENTAL CONSERVATION  
RCRA COMPLIANCE EVALUATION INSPECTION  
AND CLOSURE VERIFICATION REPORT

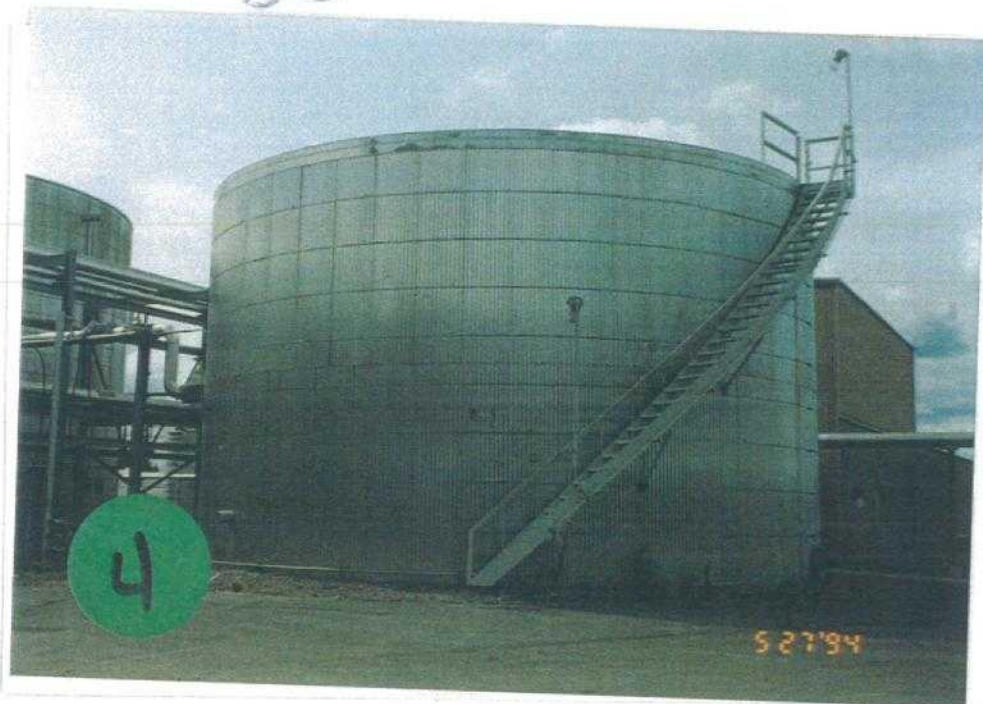
We next visited Tank 192, the facilities main oil/water separator, **Photo #4**. This is not the original Tank 192 addressed in the EPA Orders. The original tank was cleaned and dismantled in July 1989 and this new replacement tank was constructed.

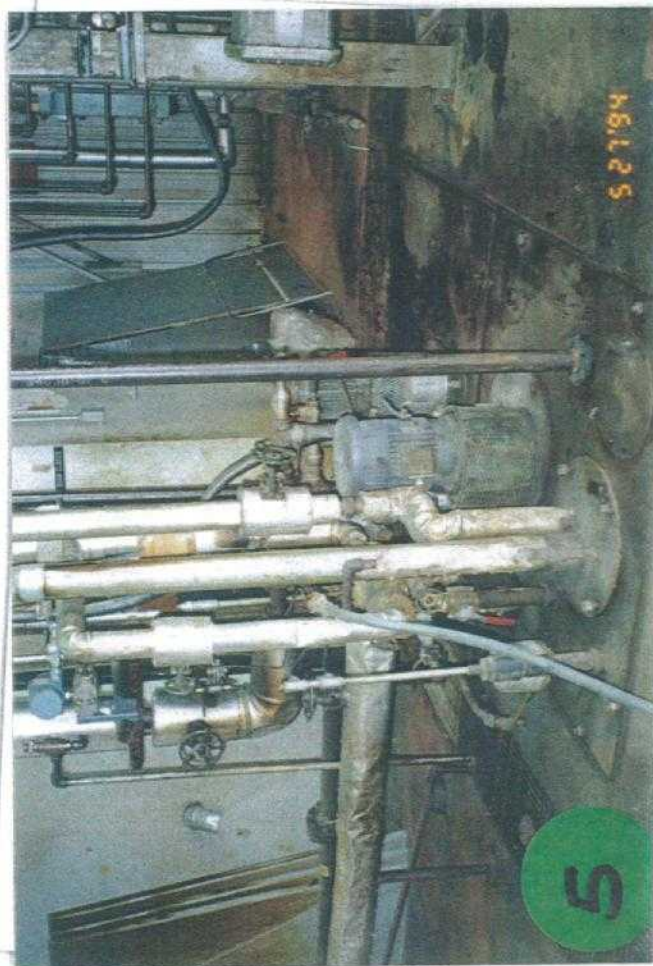
The Effluent Building is located next to Tank 192. Sump 905 is located inside this building, **Photo #5**. According to Ms. McCullom, Sump 905 receives wastewater only from the Effluent Building floor drains. Because of this, Ms. McCullom believes that including this sump as a hazardous waste management unit requiring closure in the EPA Orders was a mistake.

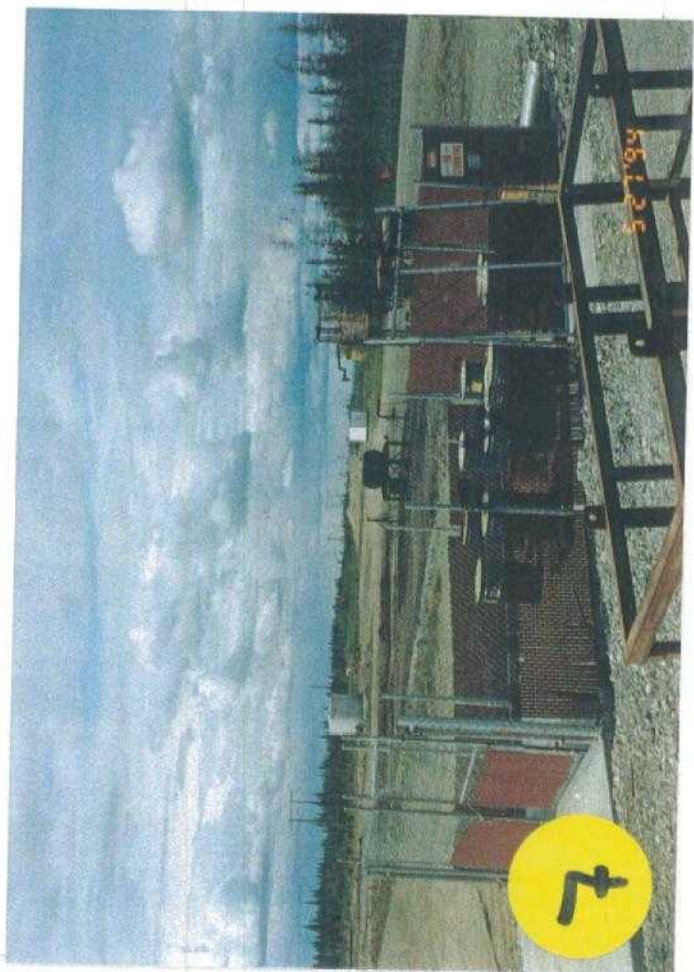
The main hazardous waste accumulation area is located adjacent to Lagoons B & C and next to the fire training area, **Photo #7**. Mr. Kany questioned why the hazardous waste accumulation area is in such close proximity to the fire training area. Ms. McCullom said she would discuss the issue with MAPI's Safety Officer and that they would ensure the fire training activities occurred in a safe manner. The hazardous waste accumulation area is a concrete lined and diked area surrounded by a chainlink fence. A blind concrete sump is in the center of the accumulation area and was filled with water. Ms. McCullom stated that the sump is pumped out on an as needed basis and discharged to Tank 192. The inspectors observed 2 1/2 drums of K050, 1 drum of F037, 3 drums of desalter sludge (D001 & D018) and 4 drums of non-RCRA spent SulfaTreat in the fenced area. All of the drums were labeled with the words "Hazardous Waste" and had accumulation start dates ranging from 5/16/94 - 5/20/94. Ms. McCullom stated that MAPI has determined the SulfaTreat is not a regulated hazardous waste based on product knowledge, **Appendix B**. Ms. McCullom also stated that the accumulation area is inspected by Ms. Brodie on a weekly basis, however, a written inspection log is not kept. The inspectors encouraged Ms. McCullom to maintain a written inspection log as evidence that inspections are being conducted at least weekly, although a written log is not required by regulation for generators.

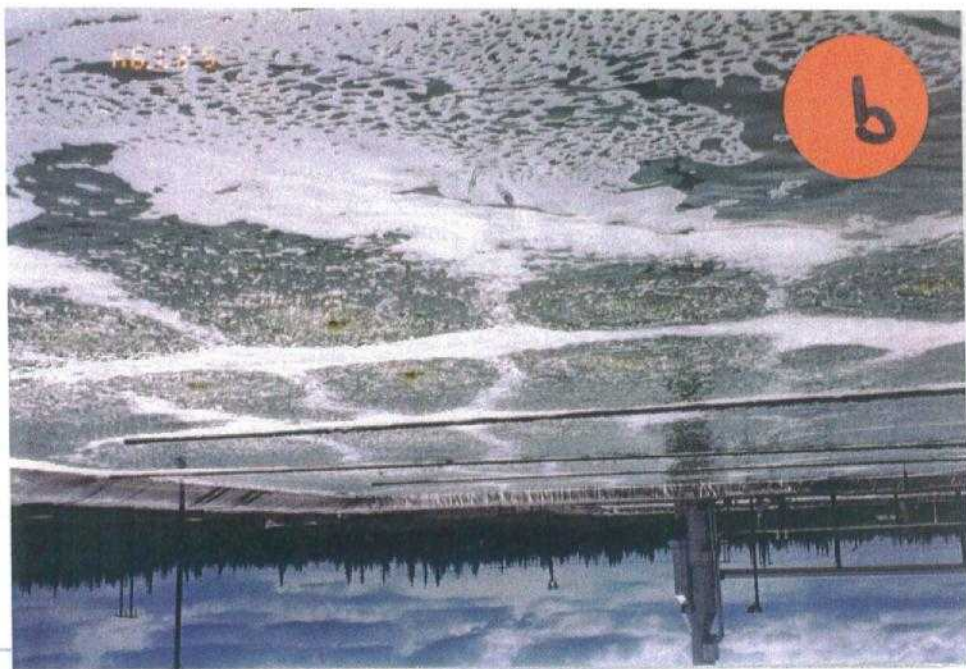
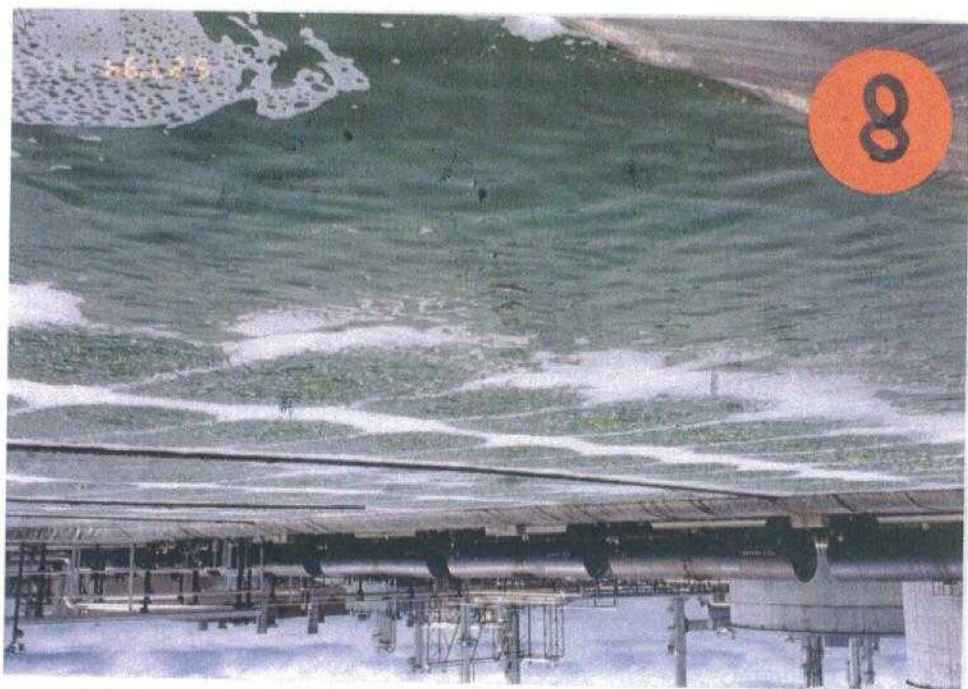
We next observed Lagoon C, **Photos #8 & #9**. Part of Lagoon C was constructed on top of the southern portion of the boneyard where illegal hazardous waste storage was observed during the 1987 CEI. MWs 111, 112, and 113 are on the western and northern perimeter of the boneyard. According to Ms. McCullom benzene has been detected in all of these MW at approximately 100 ppb. Minimal soil staining was observed in the boneyard, **Photo #10**. Soil staining was caused by present day activities and not by the hazardous waste storage observed during the 1987 CEI.

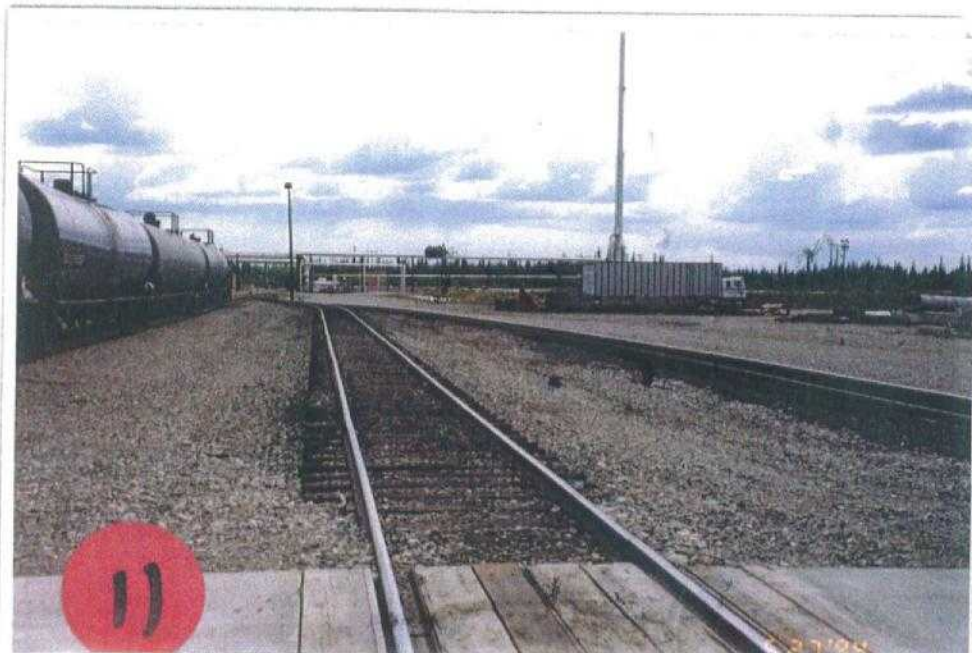
Enroute to MAPI's laboratory we observed the rail loading facility and recovery well #21. Soil staining was observed in the railbed, **Photos #11 & 12**. A vapor recovery system has been installed at the rail loading facility. **Photo #13** depicts recovery well #21.

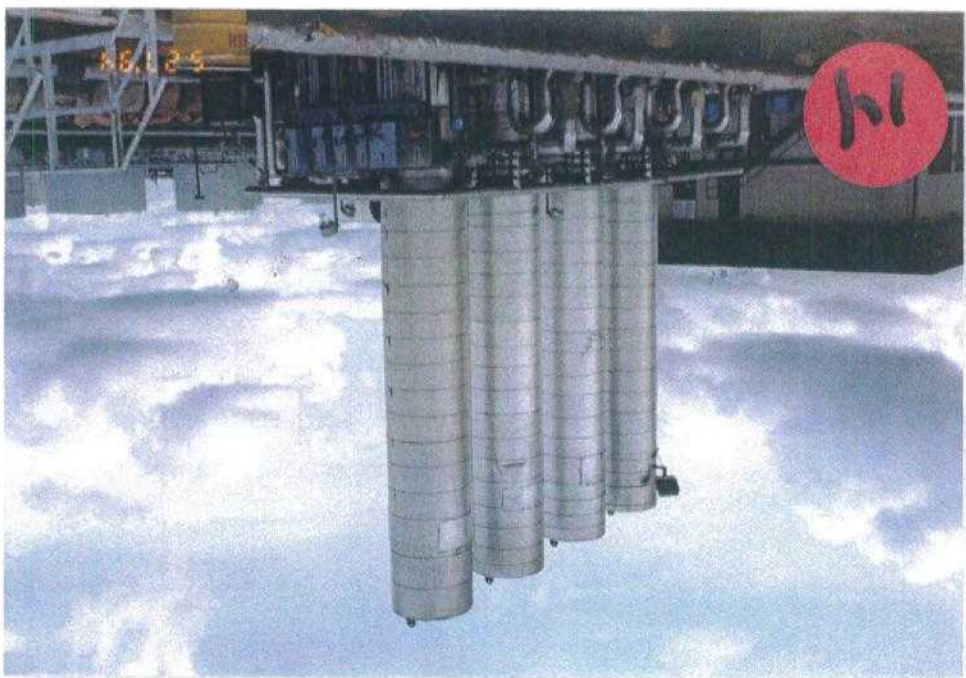
We next visited the air stripping towers used to treat contaminated groundwater generated from MAPI's pump and treat program, **Photo #14**. Treated water is directly discharged to a small holding pond prior to being discharged to a leachfield system or to two gravel pits adjacent to the wastewater lagoons. **Photo #15** depicts the holding pond. Ms. McCullom stated that the holding pond and leachfield injection system is exempt from hazardous waste regulation by 40 CFR 261.4(b)(11). This exemption is presently moot since wastewater discharged from the air strippers contains <5ppb Benzene and LDR regulatory levels have not been designated for D018 yet.
